CASE HISTORY

Enviroklean Stain CarWell CP90/Rust Cop

C&C Honolulu—Liberty Bell

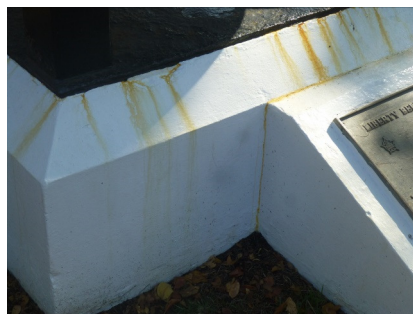
Before

C&C Honolulu has historic Liberty Bell of Aloha mounted on white concrete pedestal. The pedestal was repainted December 2014 and already the metal plate was bleeding unsightly rust stains down the sides of the pedestal. Left as is—the staining would get larger and darker and shorten the life of the paint. Not to mention an eyesore as this historic bell is located right next to City and County of Honolulu main building.

1. Apply Enviroklean Stain Remover by rag or brush.
2. Rinse with fresh water.
3. Apply CarWell CP90/Rust Cop to all exposed metal surfaces.

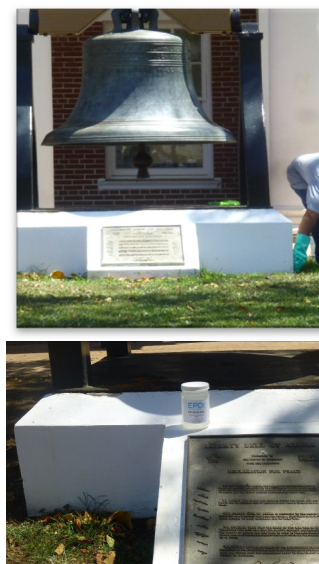
After

Use of environmentally friendly, water based Enviroklean Stain Remover easily removed the rust staining on the painted surface and applying CarWell Rust Cop rust inhibitor will provide further corrosion protection to metal plate. Follow up maintenance required on yearly basis.
