Removal of Rust Staining Caused by Crevice Corrosion

Enviroklean Reduces Manpower, Materials Cost for Maintenance

By Graham George • Sheldon Landsberger

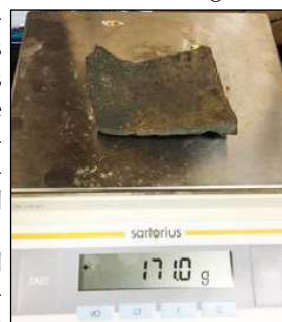
(Top right) Scale embedded on steel flange with its before and after weight related to rust treatment. (Photo Credit: Nuclear Engineering Training Laboratory, University of Texas) (At right) USS Zumwalt during cleaning. Note the left side of the ship after cleaning with EPDI's Enviroklean.

In addition to rust and rust stain removal, experiments were conducted in 2015 at the University of Texas for the removal of radioactive scale from a steel flange using EK2012 (EK S&C). After 20 hours, the EPDI product EK2012 successfully removed 20.7 grams of the rust scale and 96 percent of the radioactivity. It has been scientifically confirmed that rust scale and calcium both act as hosts to specific radioactive isotopes such as Radium-226, Radium-228 and Lead-210, which may add additional unwanted problems when present.

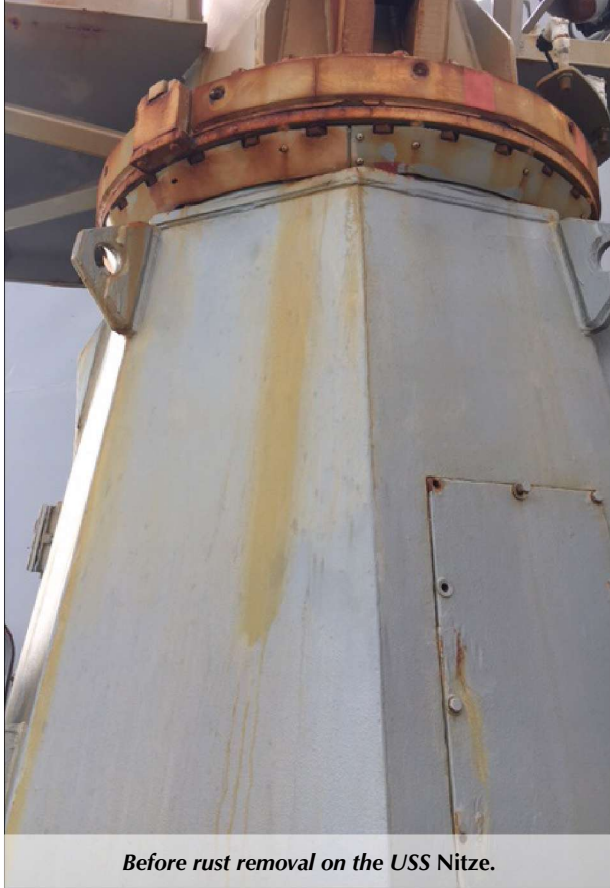
Before rust removal on the USS Nitze.
